July 3, 2003

Site Inspection, Georgia-Pacific Corporation, Hebe Mine, M/015/072, Emery County,

Utah

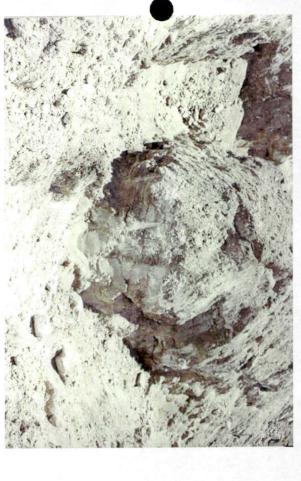
There were two locations where fill had been placed so that it blocked the drainage. Some of the material that was in the drainage has been removed so that water will not be impounded. In the uppermost of these two areas, fill was removed in such a way that there is something of a gooseneck in the drainage (Photo 1). I don't believe this will cause problems, but in a very intense storm, some of the fill could end up going down the drainage.

Photo 1. The upper area where fill was removed to create a sort of "gooseneck."

While I do not think the fill left in the drainage will cause problems, the Division and operator should monitor the drainage to see if there are signs of instability.

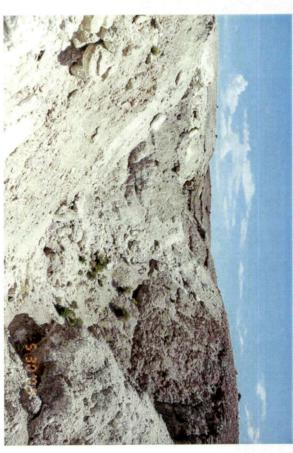
Photo 2. The lower area where fill was removed looking toward the upper area. At this angle, it is impossible to see that fill was taken from the upper area.
